Premature Wear - Socket Style Stabilizer Links

Premature wear of socket style stabilizer links on popular 1986-2007 Ford, Lincoln & Mercury applications

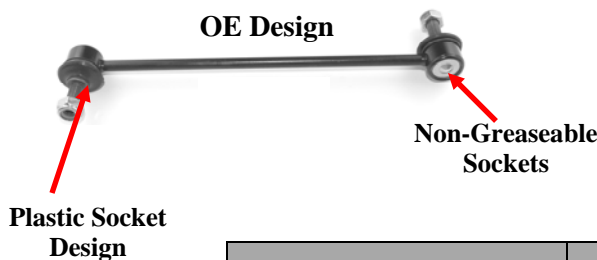
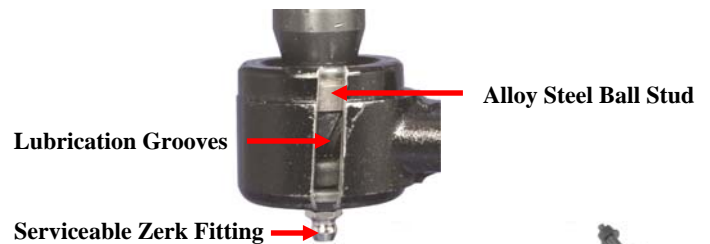
- The OE part is a plastic socket, non-greaseable design on many Ford, Lincoln & Mercury vehicles. These parts are particularly prone to premature wear which results in a rattling and clunking noise in the front end.
- Premature failure can also result from previous service with the use of air guns because wrench flats are not accessible during installation. This can cause the stud to spin within the plastic socket, creating more friction which can cause internal damage.

- Durable all-metal construction is not prone to premature wear common with OE plastic design.
- Greaseable zerk fittings allow for serviceable maintenance helps reduce friction and flush out contaminants.
- High strength alloy steel full ball stud design provides 360° of smooth, even rotational movement resulting in more responsive steering.
- Easy-access flat wrench or hex head design allow for use of hand wrench during installation.
- Ball stud includes deep lubrication grooves to allow grease to flow through and lubricate all critical areas for longer life.
