February, 2010 News Bulletin

Stabilizer Links Often The First Chassis Component to Wear Out *Falcon Steering's Design Prevents Premature Wear*

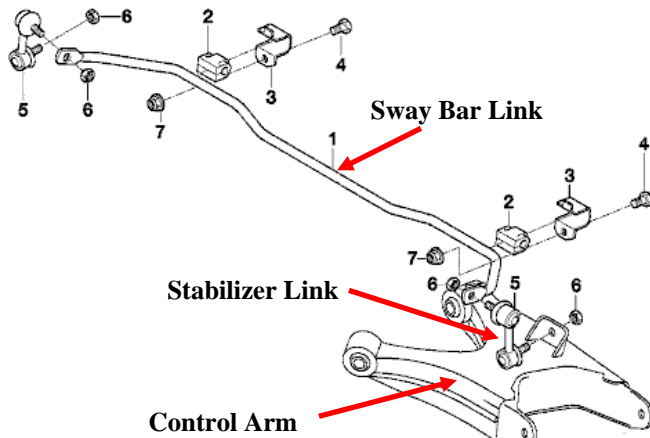
To ensure a strong durable weld, Falcon Steering produces their stabilizer link arms with 1" metal bar stock versus a 3/8" bar stock used by many competitors. This may sound like an insignificant difference, but 1" bar stock has a nearly 27% larger diameter than a 3/8" bar which provides 27% more weld surface area.

1" Bar Stock Provides 27% More Weld Surface

This helps eliminate premature weld breaks which will cause instable driving conditions. Thicker bar stock also helps eliminate excessive twisting of the stabilizer link arm under heavy torque loads.

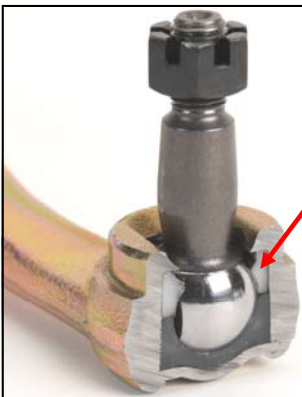
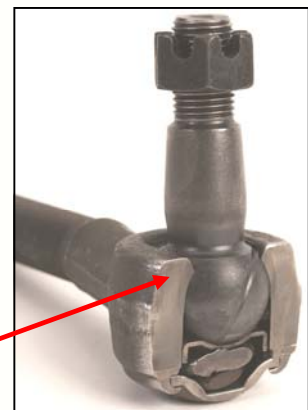
The problem with many competitive products is they use nylon bushings within the ball socket. Although this can be ideal for perfect road conditions, nylon is subject to premature wear when exposed to the potholes & bumpy surfaces of today's roads.

Falcon Steering Systems provides a premium **solution** by using high grade "Chromium Molybdenum" hardened steel ball studs and a hardened PM ball seat to ensure long lasting performance and precise steering response.
